Feltárás az aquincumi katonaváros délkeleti régiójában

Excavations in the southeastern area of the Aquincum military town

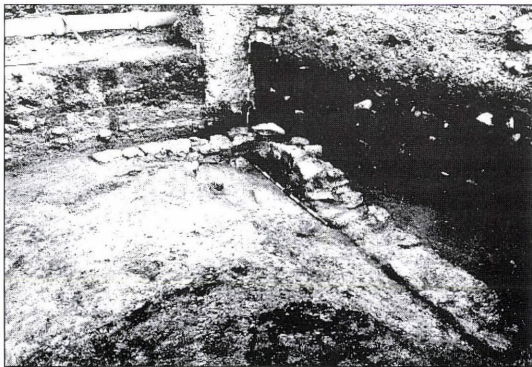
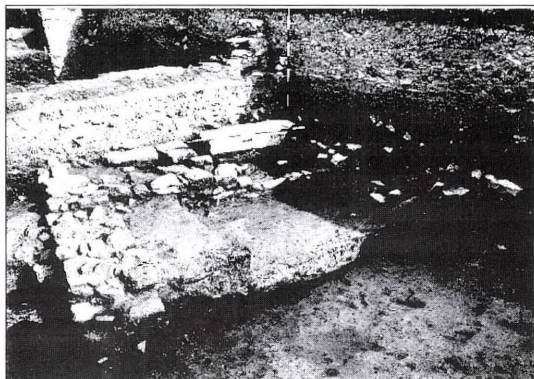
eltérő alaprajzú, igényesebb kivitelű házakat emeltek (14. és 15. kép). Falazatuk egy része a jellegzetes ún. "halszállkamintás" (*opus spicatum*) technikával készült, s a padlófűtés szerényebb, fűtőcsatornás változatának maradványát is feltártuk az egyik helyiségben. A falakat - az omladékból kibontott töredékek alapján - vörös, fehér okkersárga és türkizkék színekkel mintázott falfestmények díszítették. A ház berendezéséből mindössze egy bútorhoz tartozó bronz töredék maradt meg, sejtetve az itt élők tehetősebb voltát. Az épületektől délre, nem eredeti felállítási he-

once this building had been destroyed, more sophisticated variously oriented houses were built on the leveled surface (Figures 14 and 15). Their walls were made using the characteristic, so-called herring bone (*opus spicatum*) pattern. A modest form of hypocaust heating could be identified on the basis of heating channels found in one of the rooms. As is shown by fragments recovered from the rubble, the walls were decorated with paintings in red, ochre, white and turquoise colors. Only a surviving bronze fitting represents the furniture from this building. It is suggested the possibility, however, that the inhabitants of this house were relatively wealthy. An intact altar stone was found south of the buildings in a secondary position (Figure 16). It was erected by *Marcus Aurelius Ingenuus cornicularius*, one of the administrators of the *legio II. Adiutrix* in honor of Jupiter. Subsequently, the slowly decomposing buildings were either pulled down and levelled several times or their standing walls were used to make the foundations of new houses.

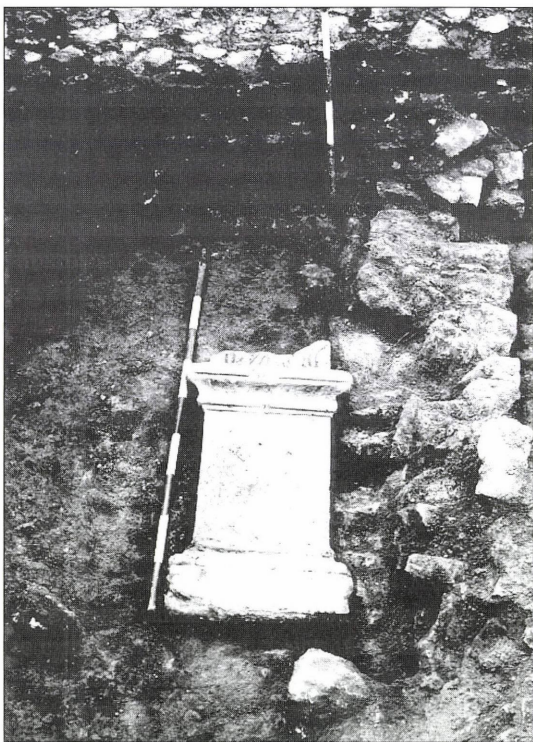
16. kép

lyén került elő egy ép oltárkő (16. kép) melyet az aquincumi legio, a *legio II. Adiutrix* egyik tisztviselője, *Marcus Aurelius Ingenuus cornicularius* állíttatott Iuppiter tiszteletére. A későbbi korokban az omladozó épületeket részben lerombolták, a maradványokat többször elplanírozták, részben a még álló falakat alapfalaként felhasználták.
