Regeneration process of the karst water springs in Transdanubian Mountains, Hungary

KRISZTINA BABÁK¹, IBOLYA KISS², ZSANETT KOPECSKÓ³, ISTVÁN PÉTER KOVÁCS⁴ and FERENC SCHWEITZER⁵

Abstract

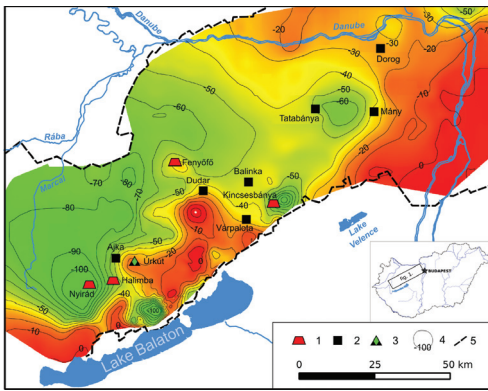
Fig. 1. Karst water level in 1990 comparing to the original karst reservoir conditions (based on CSEPREGI, A. 2007). – 1 = bauxite mine; 2 = coal mine; 3 = manganese mine; 4 = relative karst water level; 5 = border of the karst water reservoir

and near surface mines because of their depletion, which affected deep mining endangering the subsurface and karst water inrush. It went hand in hand with the active and later the passive anhydrous of the mine tunnels. Later its amount – CSEPREGI, A. (2007) calculated (estimated) an amount of 10 billion m³ exploited karst water between 1951 and 1990 – exceeded the average amount of 500 m³/s infiltration being necessary for the natural regeneration of the karst water reservoir (CSEPREGI, A. 2007). The water removals on spots or in smaller areas had an impact on the whole area because of the connected water level in the Széki Reservoir (3 km NW from Ajka). Apart from some exceptions, almost all karst springs of the Transdanubian Mountains have dried up or their yields have decreased significantly (Figure 1).

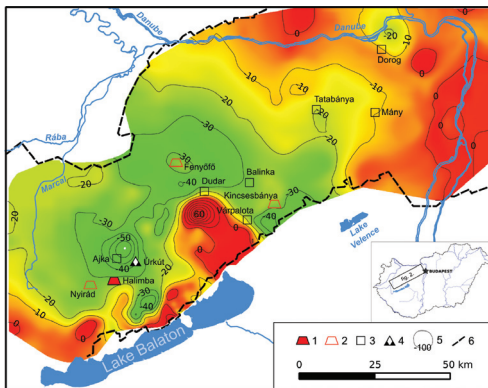
Fig. 2. Karst water level in 2006 comparing to the original karst reservoir conditions (based on CSEPREGI, A. 2007). – 1 = bauxite mine; 2 = closed bauxite mine; 3 = closed coal mine; 4 = closed manganese mine; 5 = relative karst water level; 6 = border of the karst water reservoir

Since the 1990s, the karst water level has begun to rise (Figure 2) as a result of mine closures and the dewatering works, however, at the beginning, very different and often exaggerated calculations related to the entire period of the regeneration of the reservoir emerged. According to the latest model calculations, the almost total refill of the reservoir can be expected by mid- or second half of the 2020s (CSEPREGI, A. 2007).

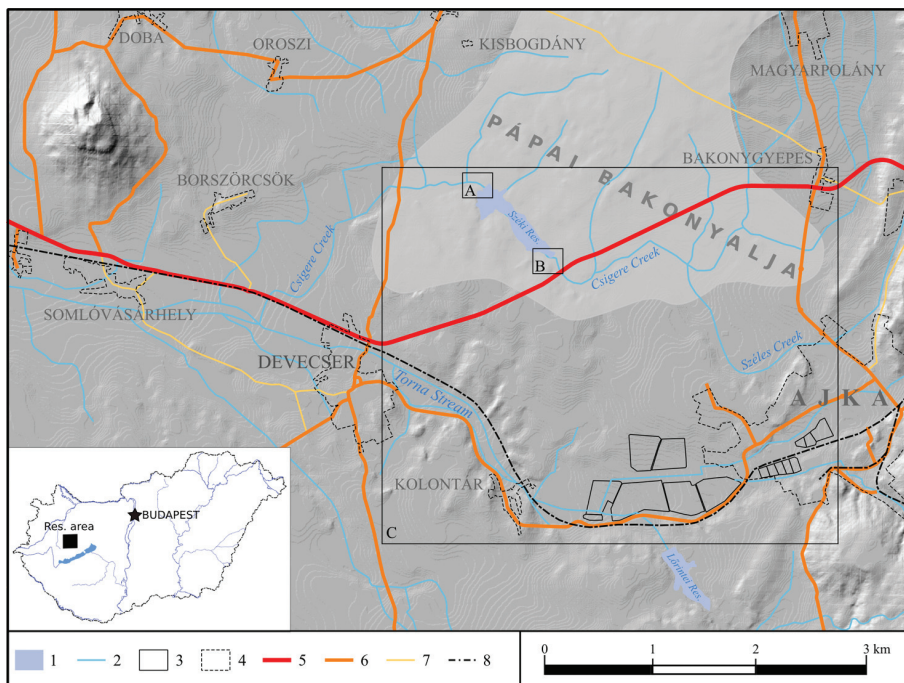
Fig. 3. Sketch of the investigated area. – 1 = water reservoir; 2 = water course; 3 = sludge reservoir; 4 = residential area; 5 = primary road; 6 = secondary road; 7 = tertiary road; 8 = railroad; A, B, C = detailed sketches (See Figs 4–7)

Our investigation area is situated in Pápai-Bakonyalja physical geographical microregion, in the valley of Csigere Creek (Figure 3). From the geomorphic point of view, it covers the lower, Southwestern part of the hillslope of the Bakony

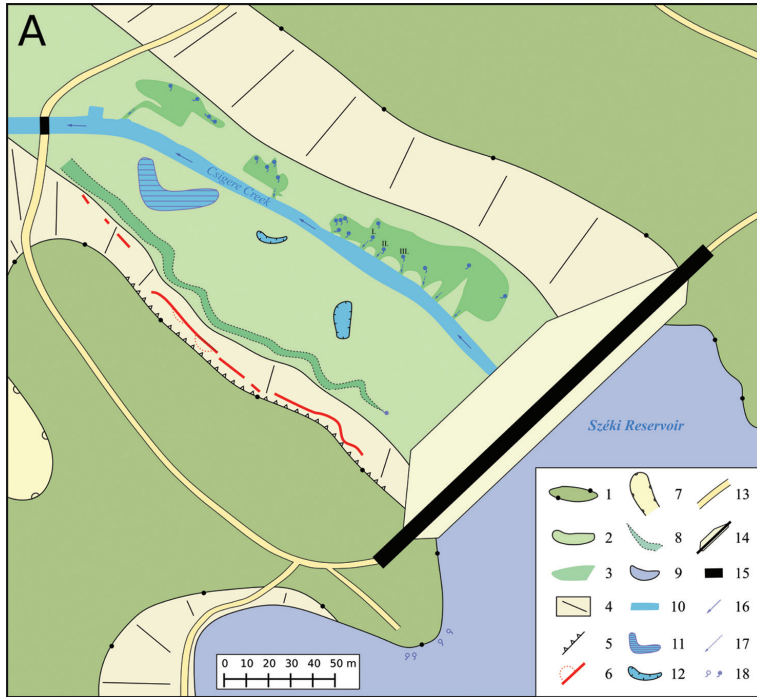
Fig. 4. Geomorphic sketch of the karst spring area, NW from the Széki Reservoir (area 'A' inside Fig. 3). – 1 = hillslope; 2 = flood plain; 3 = waterlogged surface patch; 4 = slope; 5 = high bluff; 6 = travertine with overhanging slope; 7 = dry valley; 8 = ephemeral channel; 9 = water reservoir; 10 = channel; 11 = oxbow lake; 12 = artificial lake; 13 = unpaved road; 14 = dam; 15 = bridge; 16 = waterflow direction (in the channel); 17 = water flow direction (on waterlogged area); 18 = karst springs

The height values of karst spring outlets were compared to the “original” (before the 1950s) karst water level of the izohypse maps (JASKÓ, S. 1959; CSEPREGI, A. 2007) to identify the karstic origin of the springs. The izohypses were digitised using v.digit module of Grass GIS 6.4.2. and they were interpolated with v.surf.rst module using spline interpolation (MITASOVA, H. *et al.* 2005) and 100 m horizontal resolution was applied. The DEM of the “original” karst water level was smoothed using 33×33 convolution matrix and an averaging technique. r.resamp was used to increase the horizontal resolution of the DEM of karst water level to 10 m. The DEM of the „original” karst water level was compared to the DEM of the land surface using r.mapcalculator. The map clearly shows the place where the „original” karst water level crosses the surface and it also demonstrates if the areas are under karst water pressure or not. The mineral content of water samples taken from springs were analysed to clear their origin. Results were compared to the mineral contents of karst waters published by former authors. 1.5 litre spring waters were sampled from springs 3 times during the observation period (*Figures 4 and 5*).

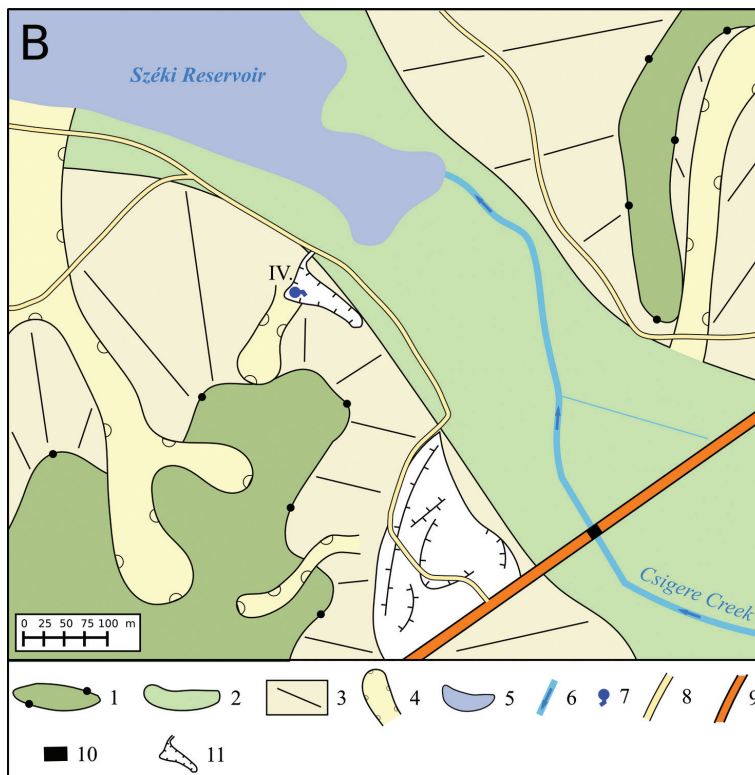
Fig. 5. Geomorphic sketch of the karst spring area, W from the Széki Reservoir (area 'B' inside Fig. 3). 1 = hillslope; 2 = flood plain; 3 = slope; 4 = dry valley; 5 = water reservoir; 6 = water course; 7 = spring; 8 = unpaved road; 9 = primary road; 10 = bridge; 11 = quarry

There is a quarry, 40 m southwest from the reservoir on Oligocene-Miocene gravels (*Figure 5*). Reed (*Poaceae australis*) patches and willows (*Salix alba*) indicates the karst water springs at the northern end of the mining claim. The spring activity is not so intense here the water leaks and fills up the mining claim. 0.5 m thick calcareous mud was deposited at the mouth of the spring, however, it's colour is lighter comparing to the mud mentioned above, probably due to the lower concentration of iron compounds.

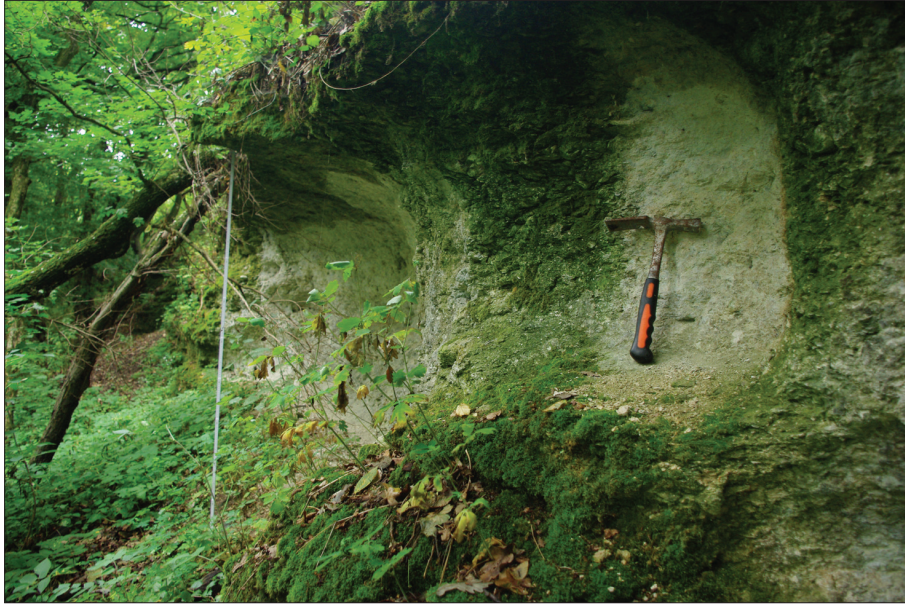
Photo 1. Typical fossil travertine structure on the steep slope of the Csigere Creek
(Photo by Kovács, I.P.)

Two – 1.8 m high, 1 m deep and 1 m high, 0.5 m deep – overhanging slope hollows (*Photo 1*) were also observed close to each other in the travertine structure. All of the observations prove a former, intense period of spring activity.

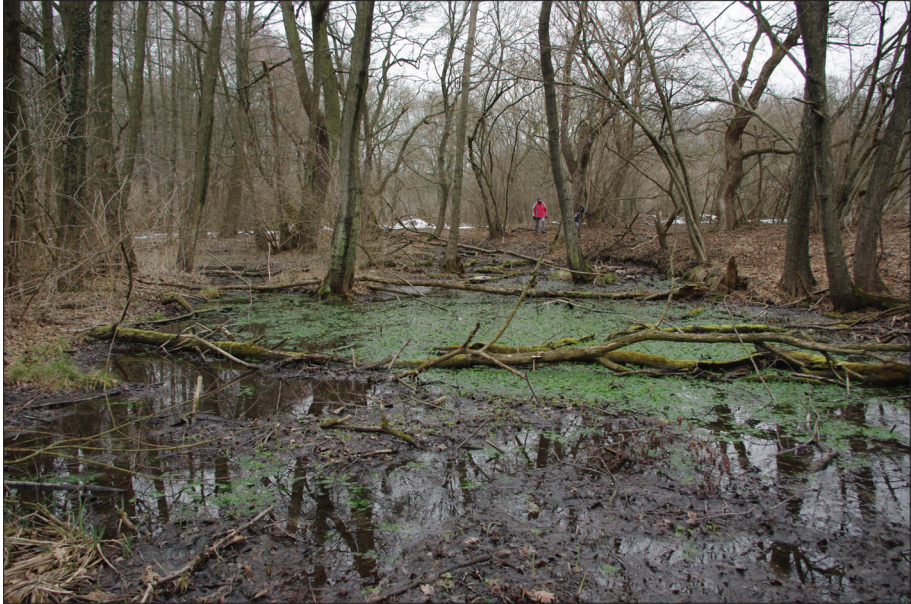
Photo 2. Warm (12 °C) karst water of waterlogged surfaces around the springs with greenery in February 2013. (Photo by KOPECSKÓ, Zs.)

The number of the identified karst water springs is lower than their real number due to their difficult-to-reach location and the dense vegetation cover. The vegetation indicates the temperature of the karst water springs (10–12 °C). Vegetation covered the waterlogged surface patches during our fieldtrips in February (*Photo 2*).

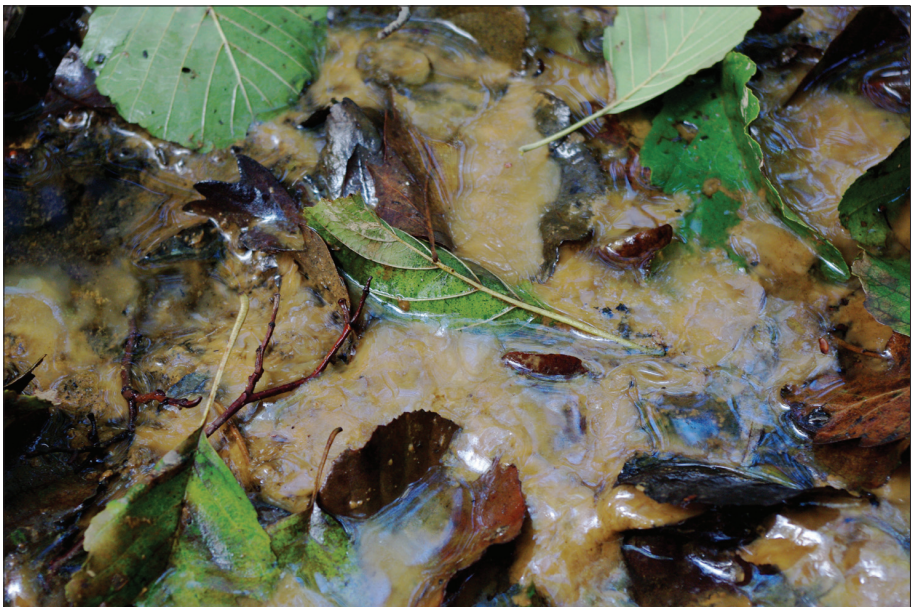
Photo 3. Leaves covered by recent calcareous mud near the springs (Photo by Kovács, I.P.)

The outflow waters run in small, 0.5–1.5 deep erosional channels to the Csigere Creek, however, measuring the discharge was impossible. The rejuvenation of the karst spring activity is shown by the recent yellow and reddish, calcareous mud and the lack of travertines in the surrounding of the springs (*Photo 3*). The calcareous mud coats leaves and boughs and it forms low rimstone barriers (*Photo 4*).

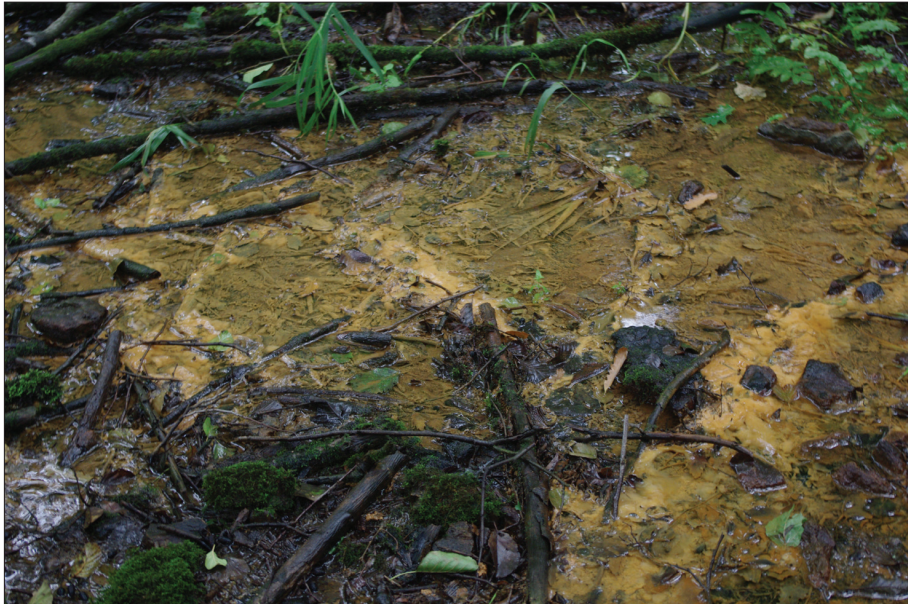
Photo 4. Approx. 3 cm high recent rimmestone dams near karst springs (Photo by Kovács, I.P.)

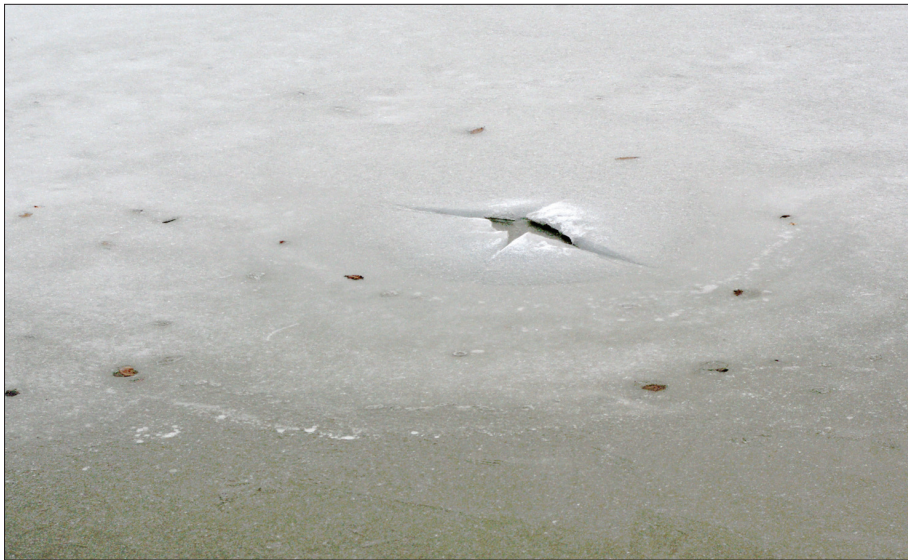
Photo 5. Underwater karst springs brake trough the ice of the water reservoir in February 2013. (Photo by Kovács, I.P.)

Underwater karst spring outlets were observed in the Northern part of the reservoir, South from the dam. The frozen underwater karst springs being warmer than the water of the reservoir melted and broke through the ice on the reservoir (*Photo 5*).

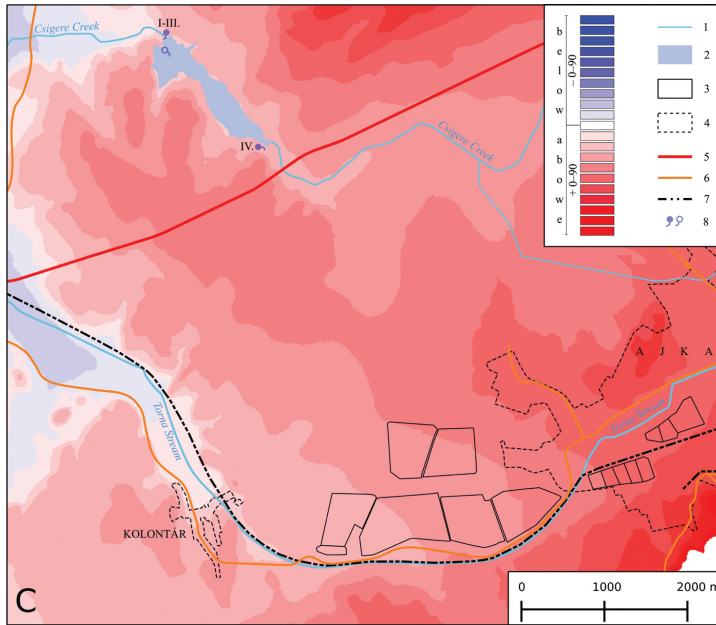
Fig 6. The height of the original karst water level (JASKÓ, S. 1959) comparing to the DEM of the surface (area 'C' inside Fig. 3). – 1 = water course; 2 = water reservoir; 3 = sludge reservoir; 4 = residential area; 5 = primary road; 6 = secondary road; 7 = rail road; 8 = karst spring (Coloured chart: the height values of the original karst water level comparing to the DEM.)

According to the results of the comparison of the "original" karst water level (CSEPREGI, A. 2007) and the height values of the mapped karst water springs (Figure 6), it is proved that the recent spring activity is under the "original" karst water level. Karst springs being Northwest from the reservoir are 4.2–5.6 m below the "original" level on average, but the karst spring west from the reservoir is just 0.5–1.5 m below it. At the red mud reservoir No. 10, the values are between 7 and 6 m, furthermore, the older sludge reservoirs are 4–6 m deeper than the "original" karst water level.

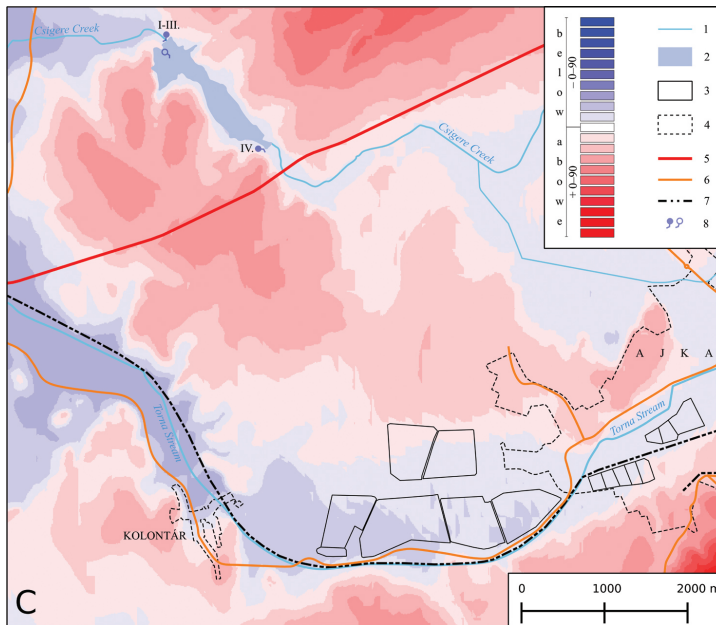
Fig 7. The height of the original karst water level (CSEPREGI, A. 2007) comparing to the DEM of the surface (area 'C' inside Fig. 3). – 1–8: For explanation see Fig. 6.

Using the "original" karst water level by JASKÓ, S. (1959), the results are quite different (Figure 7). The Northwestern karst springs are situated 3.5–5.6 m higher than the "original" karst water level, whereas the South-Western springs, reservoir No. 10 and the older sludge reservoirs are located 15–16 m, 15–20 m and 20–35 m higher, respectively, than the "original" karst water level.
